Historical Development and Some Experiences of Energy Dissipator at Multiple-Purpose Projects in Japan

IWASA, Yoshiaki; NAKAGAWA, Hiroji

IWASA, Yoshiaki ...[et al]. Historical Development and Some Experiences of Energy Dissipator at Multiple-Purpose Projects in Japan. Bulletin of the Disaster Prevention Research Institute 1965, 14(3): 65-82

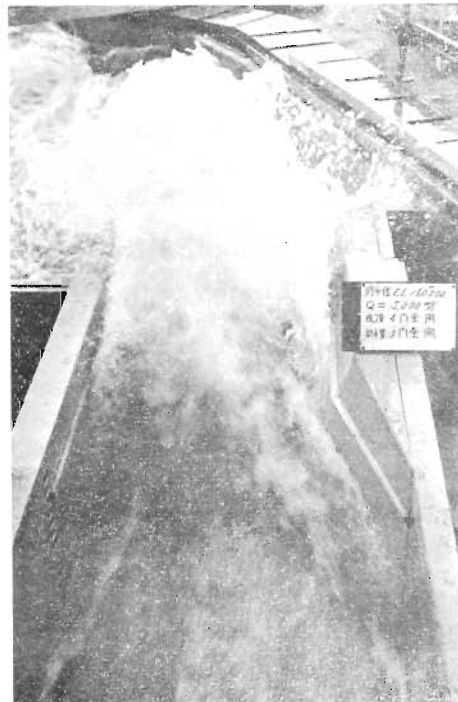
test, it has been indicated that the contraction of the apron toward downstream had an effect on shooting the flow along the curved river channel in emergency operation and on reducing the weir height to 10 m due to increase of efficiency of back-water⁶⁾. The final design of the stilling basin and the spraying flow condition in emergency operation observed in model test are shown in Figs. 8 and 9, respectively.

Fig. 9. Deflected flow condition in emergency operation (1 : 50 scale model).

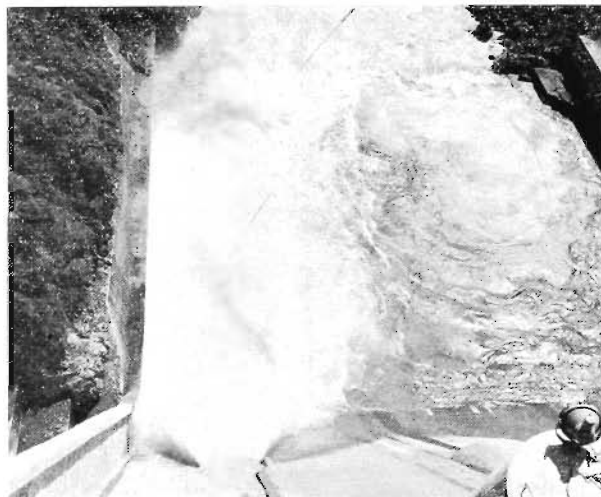
Fig. 14. Laterally back current at Tase Dam during one outlet operation.

Moreover, the coffer-dam left just downstream of the apron checked the development of the bed

roller and promoted occurrences of bed scour and lateral eddy.

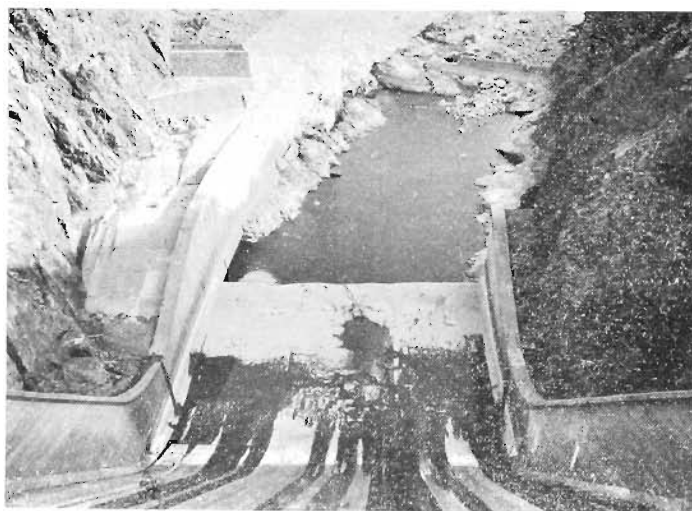
Fig. 15. Erosion at Nagayasuguchi Dam.

The first operation of the spillway was made during the flood in September, 1956, after completion of the project in 1955. Six floods of which the maximum released discharges ranged from 1,000 m³/sec. and the average period of operation was 300 hours passed over the spillway during the year of 1956 to 1957. An extensive damage was noticed at the central part of the apron and on the top of the end sill, when the basin was dewatered for inspection in January, 1958, as shown in Fig. 15. The maximum depth of erosion on the concrete floor was about 2 m and the face of guide wall on the left side was roughened by abrasion. The severe erosion on the top of the end sill would result from the cavitation, where the reinforcing steel was bent toward upstream by bed rollers.

The subsequent investigation made in 1960 after 10 flood releases with the maximum rates of 300 m³/sec. to 2,000 m³/sec. did not find the further erosion of the basin while the scour of the foundation just upstream of the cofferdam was considerably progressed. During the flood in September 1960, 4 spillway gates except 2 on both sides were operated to release water of 4,500 m³/sec., with results of failure of the part of the cofferdam and the protection wall of the downstream channel.

Causes of erosion and failure were thought to be the following: In design, though the front of jump is secured in the basin for discharges less than 1,500 m³/sec., the length of the apron is so short the bed erosion between the apron and the cofferdam is severe, and that the lateral eddy current which occurs due to the uneven distribution of the incoming flow and curvature of the exit channel draws the scoured debris into the basin, with results of severe abrasion of the concrete floor. For discharges over than 1,500 m³/sec., the tailwater depth held by the cofferdam is so insufficient to form a hydraulic jump that the flow deflected by the end sill causes a deep erosion of the channel bank. As to construction, the erosion patterns of the apron which are different between three blocks may be verified by the fact that the placing period, the quality and strength of concrete were varied each other. Cavitation damages on the sill may be accelerated by a rough concrete surface placed at the curved section. As to actual operation, when all spillway gates are operated at uniform opening, the flow concentrating to the central part of the basin will occur and result in reduction of the stilling action. For the topographical condition, the abrupt bend of the exit channel will cause a lateral back roller at the upstream portion of the cofferdam.

In 1962, the eroded parts of the apron and protection-wall were repaired by replacing the concrete, and the damaged river bank was protected by derrick stones, which have indicated a satisfactory performance against flood releases thereafter.
